Court Condition Assessment & Professional Findings

This report outlines the observed conditions of the court surfaces, contributing factors, and recommended corrective actions. The goal is to support informed decision-making aligned with long-term playability, safety, and facility stewardship.

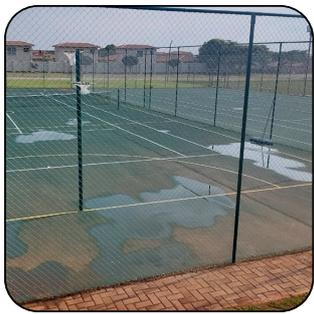
Surface Ponding

Certain areas of the court retain water after rainfall or washing. This indicates that the surface is no longer achieving the recommended true-plane drainage slope. Standing water accelerates surface wear and supports algae growth.

Recommended Action: Correct low areas ('birdbaths') and re-establish a consistent slope of approximately 0.83–1.0% (1:120 to 1:100), in line with industry guidance.

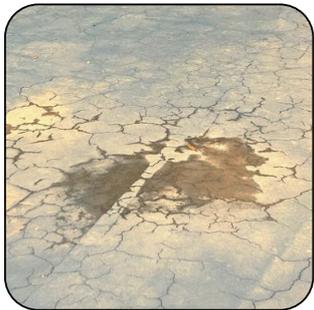
Subsurface Moisture & Soft Spots

Moisture infiltration beneath the surface can weaken the underlying structure and lead to localized soft areas or future cracking.

Recommended Action: Address drainage pathways and reinforce affected zones to restore structural stability.

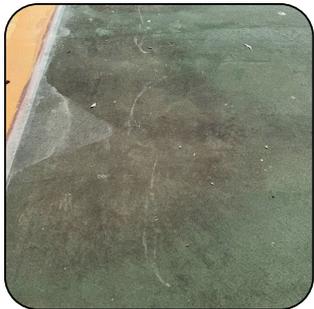
Weather Exposure & Surface Wear

Outdoor hard courts experience year-round weathering. Inadequate stormwater management can increase wear rates.

Recommended Action: Resurface using an all-weather acrylic polymer system engineered for outdoor performance in high-traffic school environments.

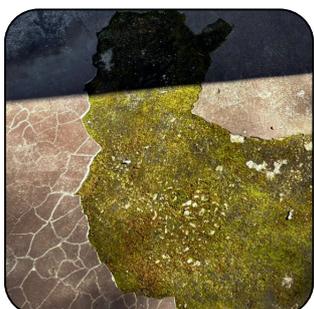
Algae or Moss Growth

Algae or moss may appear in shaded or consistently damp areas, reducing surface traction and increasing slip risk.

Recommended Action: Improve drainage and sun exposure where practical, clean affected surfaces, and re-texture during resurfacing to restore safe grip.

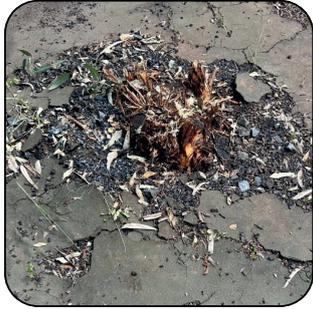
Tree Root Interference

Tree roots may cause surface lifting or uneven playing conditions.

Recommended Action: Remove or reduce root intrusion and repair affected areas to maintain level play.

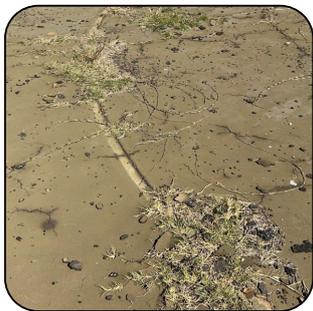
Grass & Weed Edge Intrusion

Vegetation encroaching at the court perimeter allows moisture entry and compromises the surface bond.

Recommended Action: Excavate and seal edges to prevent regrowth and improve moisture resistance.

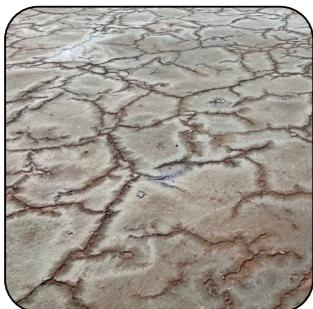
Structural Cracks

Cracks indicate movement in the base layers. Surface coatings alone will not fully resolve these conditions, though appropriate crack repair and resurfacing can limit further propagation.

Recommended Action: Repair and seal cracks before resurfacing with a flexible acrylic polymer coating designed to mitigate crack telegraphing.

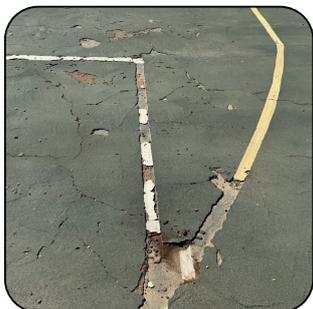
Delamination (Layer Separation)

Separation of coating layers indicates compatibility or preparation issues.

Recommended Action: Remove loose material and resurface using a compatible acrylic sports-surface system with correct surface preparation.

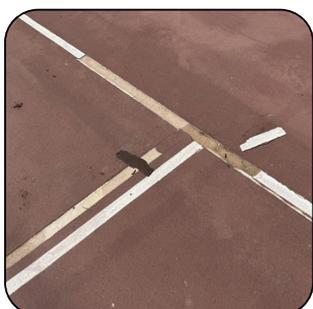
Court Line Paint Compatibility

Some existing line markings appear to use non-acrylic paint, which may reduce adhesion and durability.

Recommended Action: Reapply lines using 100% acrylic, sport-grade line paint formulated for textured hard courts.

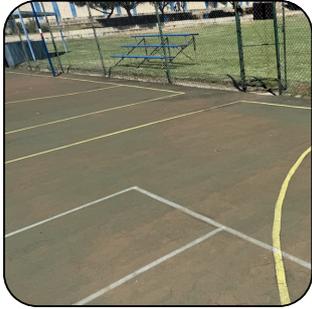
Surface Texture & Traction

A slippery or overly smooth surface may result from wear, contamination, or loss of texture.

Recommended Action: Clean the surface and restore texture during resurfacing. Slip resistance may be evaluated where needed (e.g., ASTM E303).

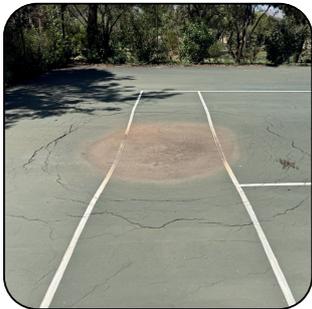
Potholes & Depressions

Surface depressions or potholes typically result from subsurface voiding or insufficient base compaction.

Recommended Action: Rebuild affected areas using proper base preparation and layer bonding techniques.

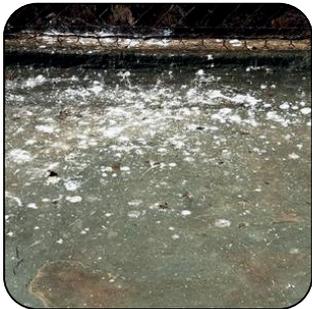
Bird Droppings (Uric Acid)

Bird droppings are highly acidic and can chemically degrade acrylic coatings if not removed promptly. Overhanging trees increase accumulation.

Recommended Action: Trim foliage to reduce contamination and maintain regular cleaning to prevent surface erosion

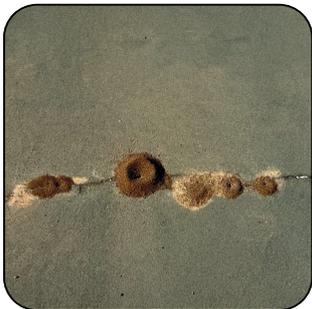
Ant Activity Beneath the Surface

Ant burrowing may create voids near court edges, potentially affecting structural stability.

Recommended Action: Apply consistent ant control treatments. If activity persists or contributes to subsurface voiding, engage a licensed pest control service before repair work proceeds.
